Remote sensing documentation of historic rangeland remediation treatments in southern New Mexico

Keywords: rangeland remediation, remote sensing, aerial photography, shrub removal, water spreading, new Mexico

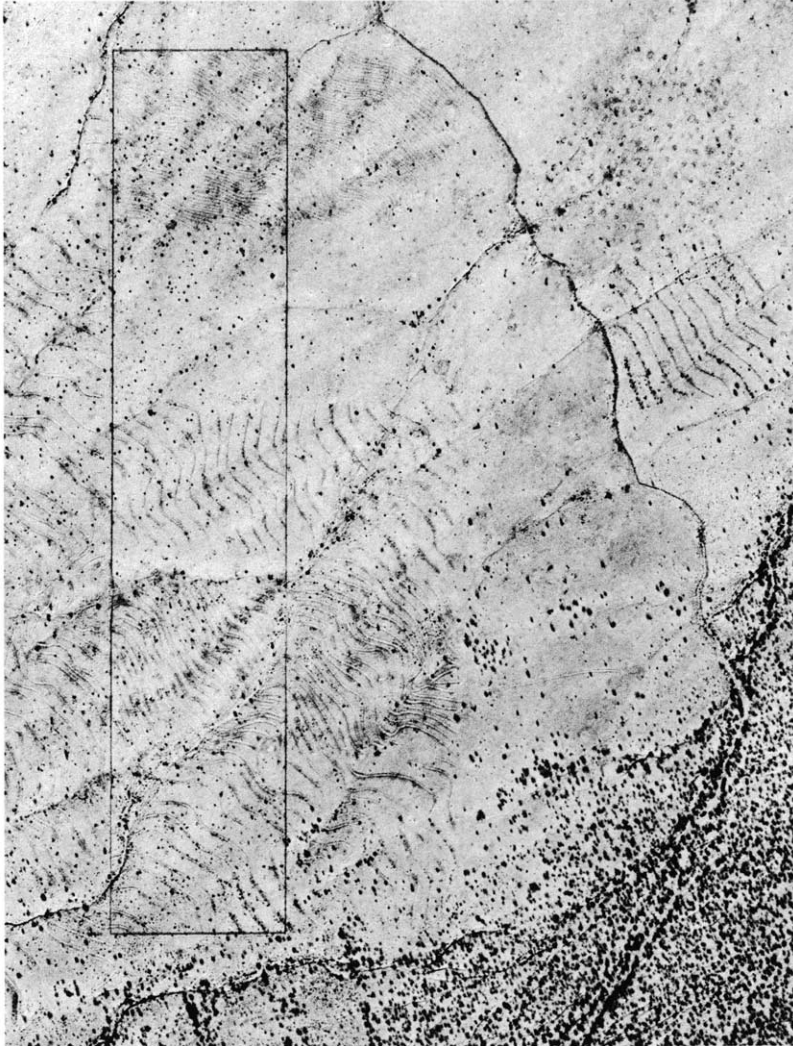
Figure 7. 1947 aerial photo of CDRRC enclosure 18. Five plots are inside the enclosure as delineated by the dark fence line (and protected from rodent effects) and five more identical plots are outside the fence to the east (and not protected from rodent effects).

There is very little evidence today that Enclosure 18 ever existed other than some very regular rows of wooden stakes delineating some plot boundaries. All fencing has been removed from the area. Valentine (1947) pointed out that soil moisture measurements in and around Enclosure 18 revealed that none of the contour treatments provided any increase in soil moisture. The lack of response in perennial

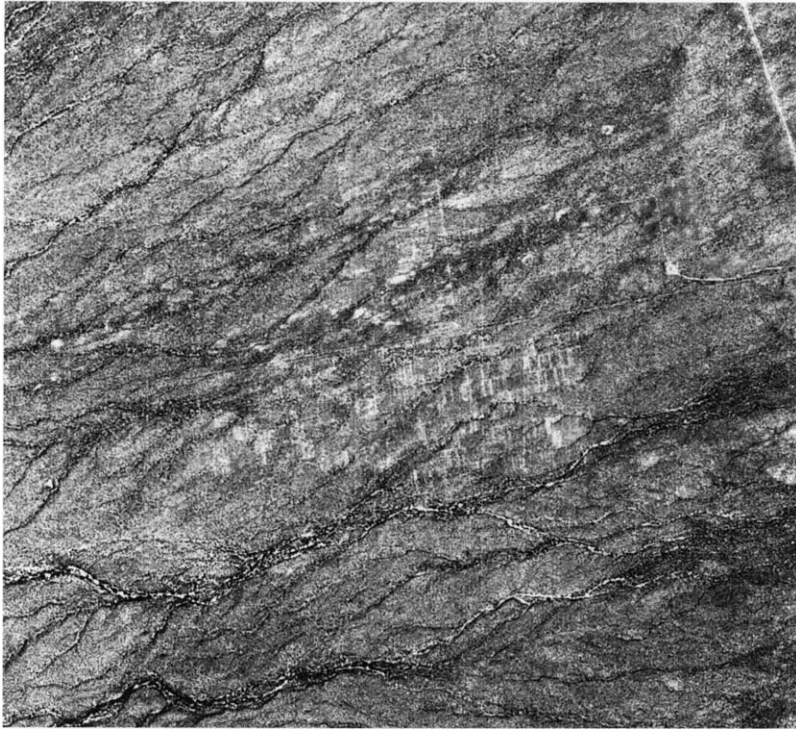
Figure 8. 1974 aerial photo of JER pasture 6 south and west of Doña Ana Revegetation and Rain Gauge Enclosure where a rectangular plot pattern of unknown treatments exists.

because it covers a large, remote area (26.5 ha) south and west of the Doña Ana Revegetation and Rain Gauge Enclosure. About one-half of these plots actually are in the North Plot of the larger Doña Ana Enclosure (formerly known as the Moisture Conservation Enclosure). Today, some of these undocumented plots remain nearly free of any vegetation, whereas others are covered by a sparse vegetation, and others have a normal shrub cover consisting mostly of creosote. No one interviewed or taken to see these plots in 2000 was previously aware of their existence. No reference to these plots was found in existing reports or files. They are not present on the 1937 aerial photography and were first noticed on the 1974 aerial photography (see Fig. 8). Because of the extent of these plots and the labor required to put them in and manipulate the vegetation, it is likely that they were established in the late 1930s or early 1940s before the CCC left the region. It is very unusual that no reference or documentation could be found considering the effort that was required to work in this remote region. Uncovering additional details about these plots would be valuable for retrospective studies. Initially, it appeared that there was a large gap in aerial photo coverage over this portion of the Jornada basin between 1937 and 1974. Recently, military and private company aerial photos from 1940s to 1950s were located and ordered for this region. When received, they should help determine at least when the plots were installed.

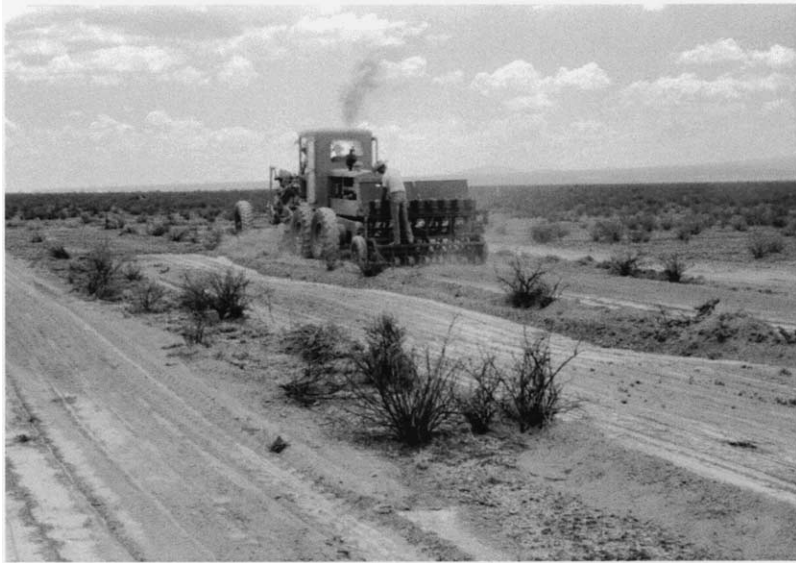
Figure 10. Road grader and grass seeding equipment operating in tarbush area of JER pasture 6 in 1964.

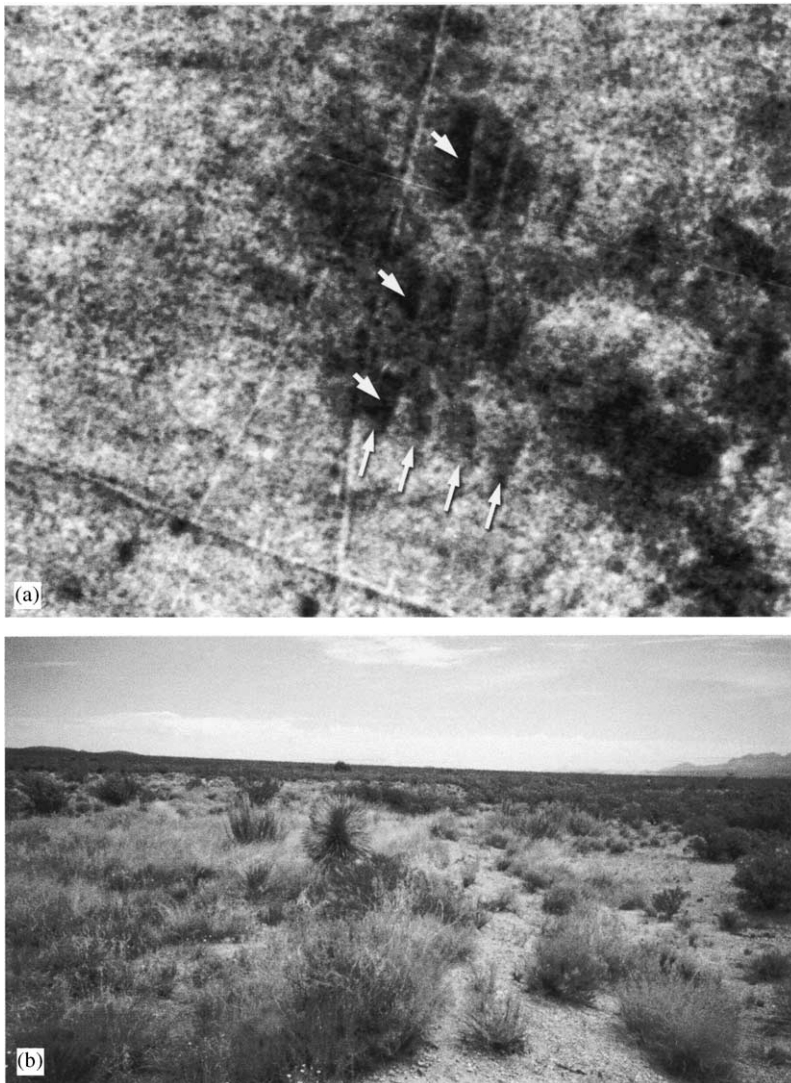
Figure 11. (a) 1986 aerial photo of JER pasture 6 west side showing 12 dikes constructed to retain surface runoff for infiltration and combined with seeding of various grasses (white arrows point to abundant vegetation growth areas upslope from dikes). (b) Ground view of grass and associated vegetation growth upslope from dikes in (a) taken in 1999.

In 1981 at the south end of JER pasture 6, 12 slightly crescent-shaped dikes designed to impound about 15 cm of water before any excess overflowed around the ends of the dikes were built (Tromble, 1981). The dikes are about 30 cm high and about 60 m long. The gravelly-loam soils of the impoundment areas were rootplowed to eradicate shrubs and drill-seeded with sudangrass (*Sorghum bicolor* spp. *drummondii*), blue panicgrass (*Panicum antidotale*), alkali sacaton (*Sporobolus airoides*), and Lehman lovegrass (*Eragrostis lehmanniana*) according to JER annual progress reports. Seeded species have not survived, but the more favorable environment created by the dikes has led to relatively lush growth of native species, and the dike area in recent imagery has a much lower reflectance (see Fig. 11(a)) indicating significant vegetation growth covering the normally highly reflective soils as shown in the ground view in Fig. 11(b). This reinvasion by native species has also occurred on other areas where

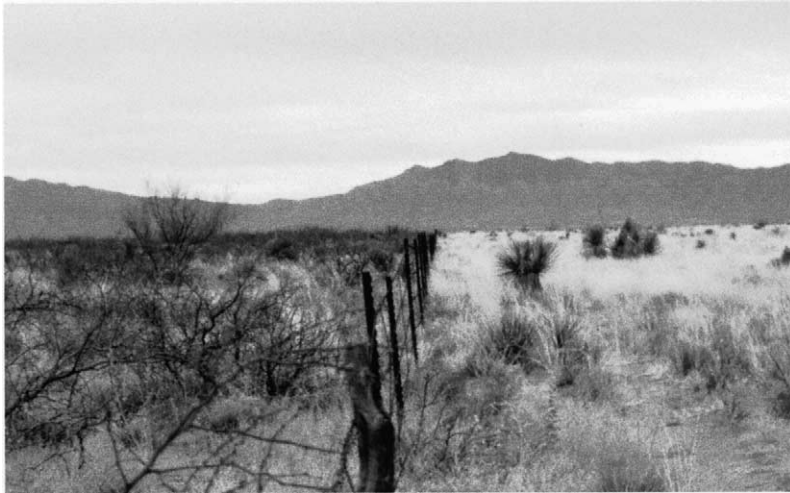
Figure 13. Ground view of the fenceline contrast shown in Fig. 12, inset (A) with BLM land on the left and CDRRC land on the right.
