# The Utility of Historical Aerial Photographs for Detecting and Judging the Effectiveness of Rangeland Remediation Treatments

Albert Rango, Kris Havstad

*Environmental Practice* 5:107–118 (2003)

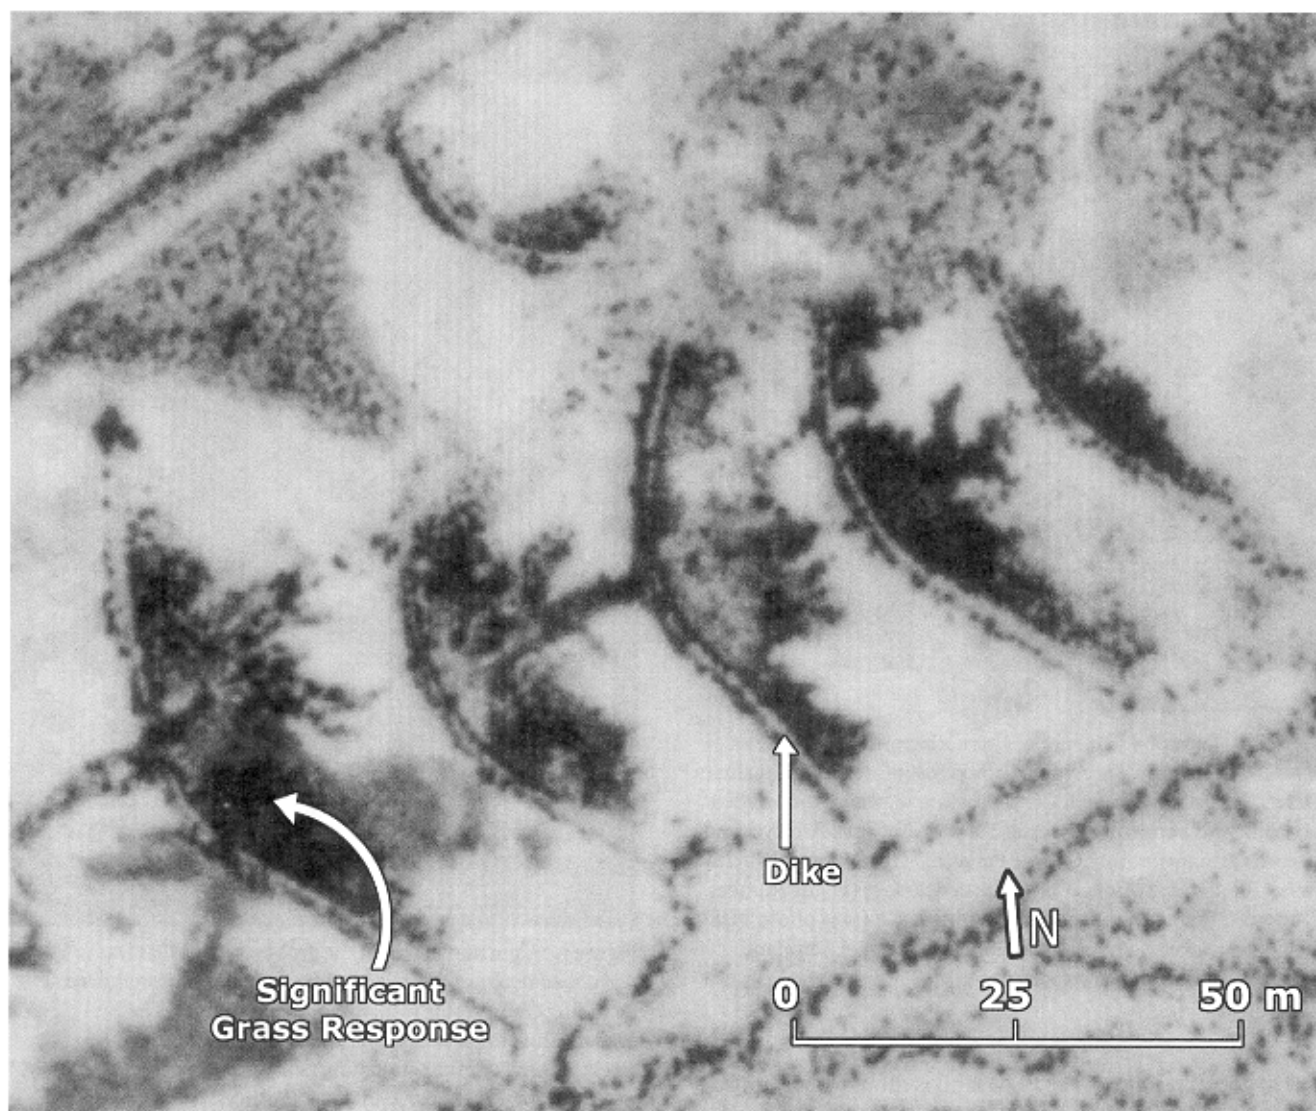
**Figure 5.** 1994 aerial photograph of water ponding dikes on the Jornada Experimental Range near Ace Tank; these were established in 1975. The photo indicates a positive vegetation response to treatment. (Source: US Environmental Protection Agency.)

Figure 5 illustrates the appearance, in a 1994 air photo, of water ponding dikes established on bare soil areas in 1975 on the Jornada Experimental Range. Originally abandoned in the early 1980s because of a lack of vegetation response to this treatment, native vegetation was observed behind the dikes 20 years later, after several significant precipitation events. Such water ponding approaches may be effective on these fine-loamy soils in increasing soil moisture and allowing the reestablishment of grass cover.

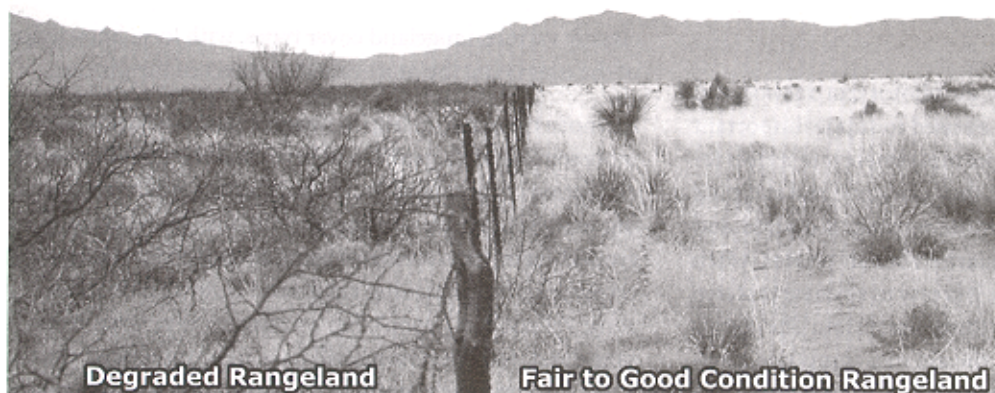
**Figure 9.** Ground-level view (looking east) of the fence line contrast shown in Figure 8, with Bureau of Land Management land on left (degraded condition) and Chihuahuan Desert Rangeland Research Center land on right (fair to good condition). (Source: Dr. Albert Rango.)

fair to good condition, the BLM land is more heavily grazed, and the Jornada Experimental Range land to the east is somewhere in between. This contrast results from differing grazing practices and the effect of herbicide kill of shrubs. Figure 9 is a ground-level photo looking east along this fence line, with BLM land on the left. Areas with good forage condition can be identified in air photos by simple comparisons with pasture locations known to have good forage, determined by ground inspection (ground truth).
