BULLETIN 341
NOVEMBER, 1947

**Effect of Water-Retaining
and Water-Spreading Structures
in Revegetating Semidesert
Range Land**

By K. A. VALENTINE

AGRICULTURAL EXPERIMENT STATION
New Mexico College of A. and M. A.
State College

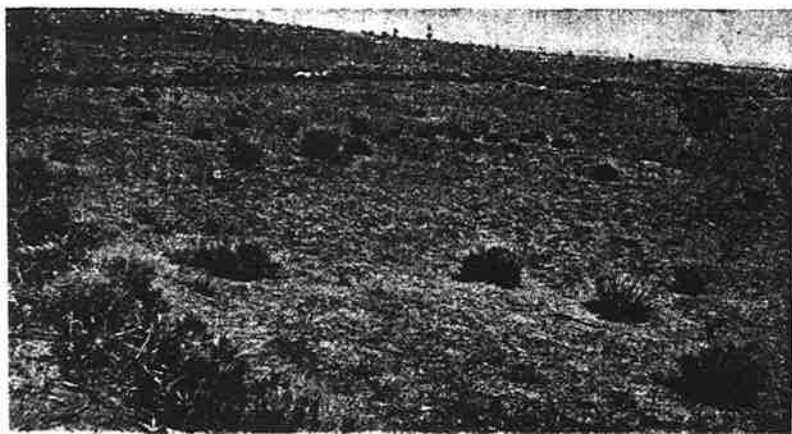
Fig. 2.—View of brush spreader across a slope showing the vegetation above the spreader and the sparse cover below. The area below the spreader shows the improvement in the area.

Vegetation on the area covered by the spreaders is varied. Part of the area is covered by a fairly good stand of black grama grass; part is covered by a good stand of black grama and tobosa grasses; part by a creosote bush type in which only a light stand of grass occurs; and part is covered by a very sparse stand of fluffgrass and annual grasses and forbs. A part of one of these spreaders constructed on this sparsely vegetated site is shown in figure 2.

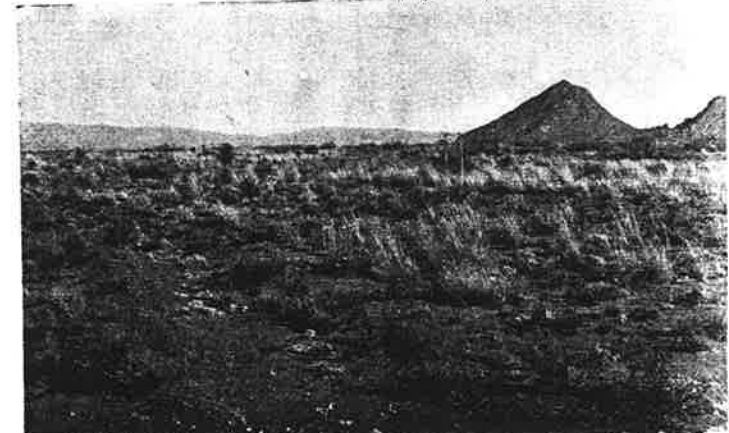
Fig. 4.—View of a contour structure. Vegetation such as appears in this picture also occurs off the treatment area and is therefore not considered to have resulted from concentration of the structure.

This type of structure consists of a flat bottomed trench about 6 inches deep and 24 to 30 inches wide, with the soil removed from the cut thrown up into ridges 6 to 8 inches high on the surface at each side of the trench. They were made with a road ripper which had a piece of steel fastened across the teeth. The channels were constructed on the contour at intervals of 25 to 75 feet on a slope varying from 2 to 3 percent. About 50 to 60 acres were treated with this type of structure in 1939.

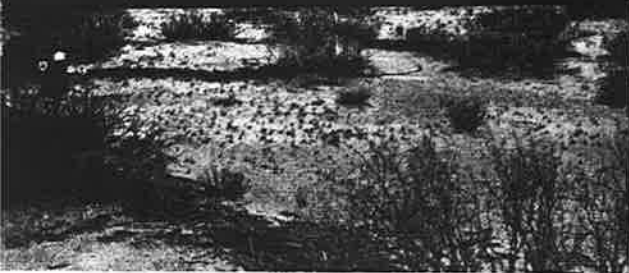
Fig. 5.—View of mesquite sand dune area showing brush "dams" constructed between dunes. This treatment was not effective in bringing about improvement of the area.

These structures consisted of elongated piles of brush placed across the slope between mesquite-capped sand dunes. The brush piles were about 12 to 16 inches high and about 18 to 24 inches broad and were tied down by cross wire ties similar to those used on the brush water spreaders. Distance between these structures was about 10 to 30 feet. The slope is about 2 percent. An area of about 200 acres was treated by these brush dunes in 1937.
